ARCHAEOLOGICAL INVENTORY SURVEY

**Hayfork Airport Improvement Project,
c. 78.6-acres, Trinity County, California.**

±86-ACRE HAYFORK AIRPORT STUDY AREA

COMMUNITY OF HAYFORK, TRINITY COUNTY, CALIFORNIA

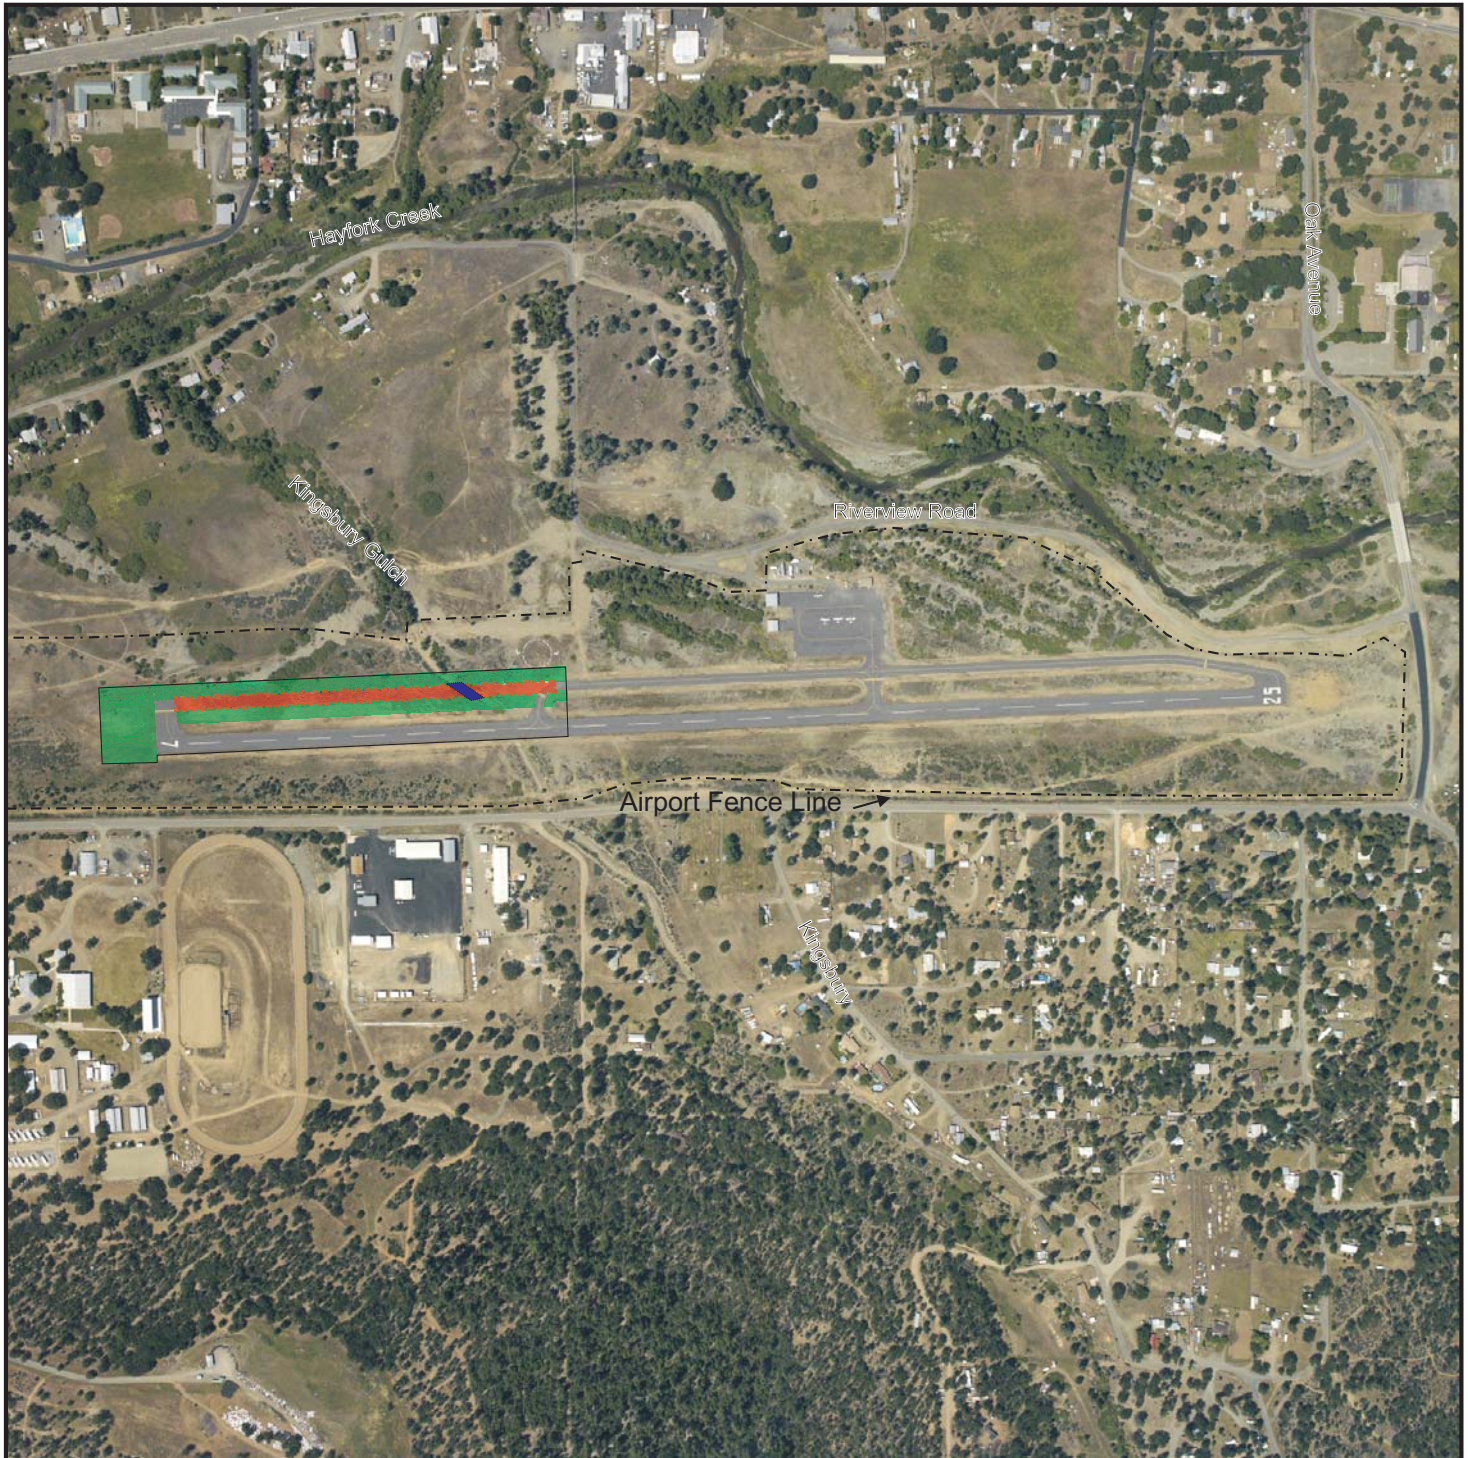
Figure 2

Proposed Project Locations

- Taxiway Extension
- Runway Safety Area and Taxiway Safety Area Grading
- Culvert location

This report details the results of an archaeological inventory survey for the proposed Hayfork Airport development project involving 78.6 acres within the overall 122 acres comprising the Hayfork/Trinity County Airport, in Hayfork, Trinity County, California. The Area of Potential Effect (APE) consumes the western portion of the overall airport property. The proposed action involves: extending the existing taxiway to the full length of the runway; constructing a culvert structure where the taxiway extension crosses Kingsbury Gulch; grading and clearing the taxiway safety area on either side of the taxiway extension; and grading and clearing the runway safety area 240' from the west end of Runway 7-25 (see Figure 2).

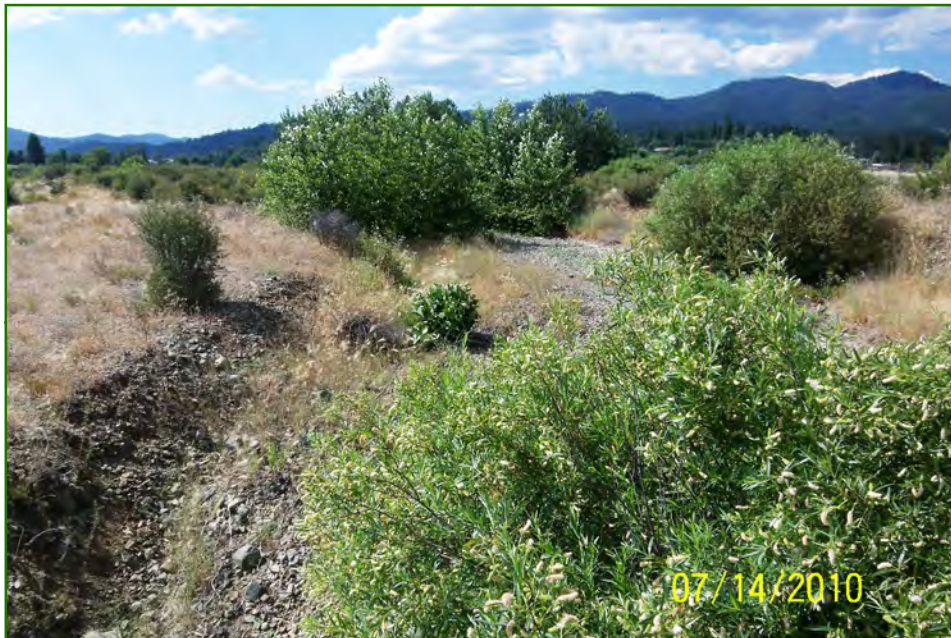
5b. Kingsburry Gulch near runway looking downstream to the north.

An Intermittent Stream (Kingsbury Gulch) flows south to north across the project area. The stream flows under the runway and into Hayfork Creek. Kingsbury Gulch flows intermittently from the beginning of the wet season through the winter and spring months. It was dry during our fieldwork in Mid July. The streambed is mostly unvegetated. Willow and cottonwood intermittently line the banks, particularly the east bank. The channel bed is a mix of gravel and rocks.

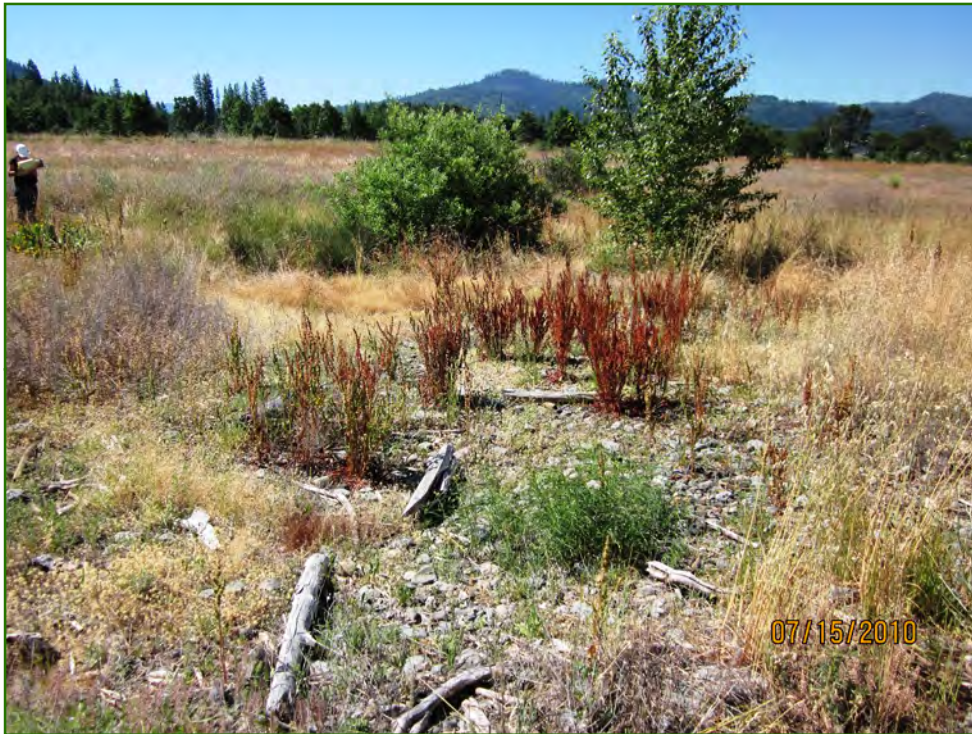
6a. Seasonal wetland (at data point #10). Shallow depression lacking woody vegetation.

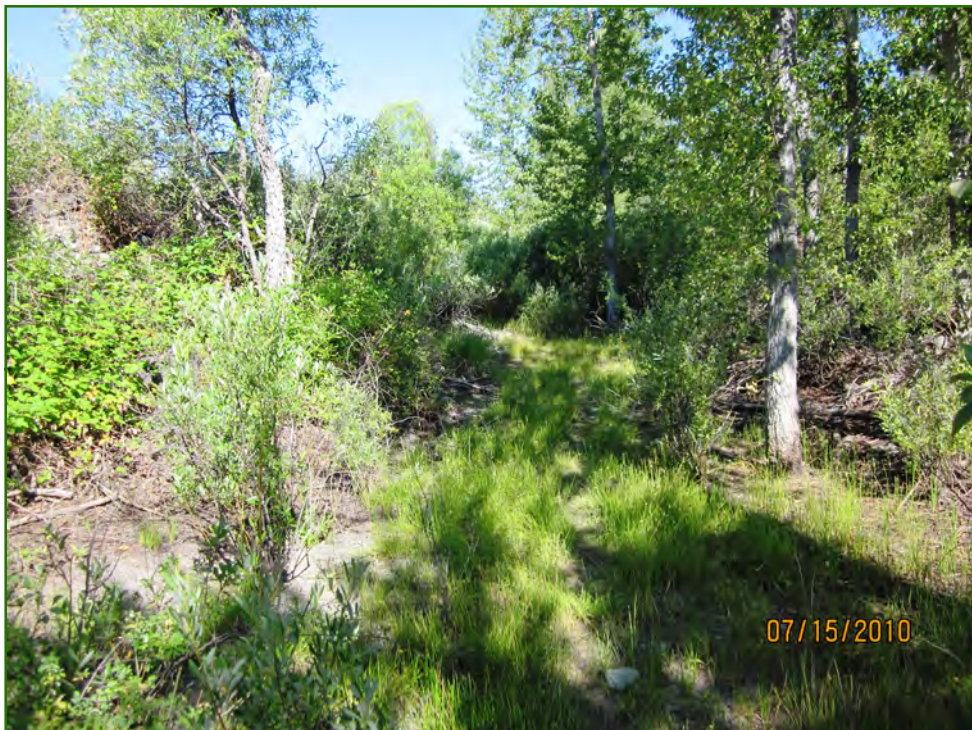
6b. Seasonal Wetland (Dredge Hollow wetland near data point #7) in northeast area of project site.
